Assessment of the Generator, UPS and Dedicated Power Circuits for the National Credit Regulator

September 2019

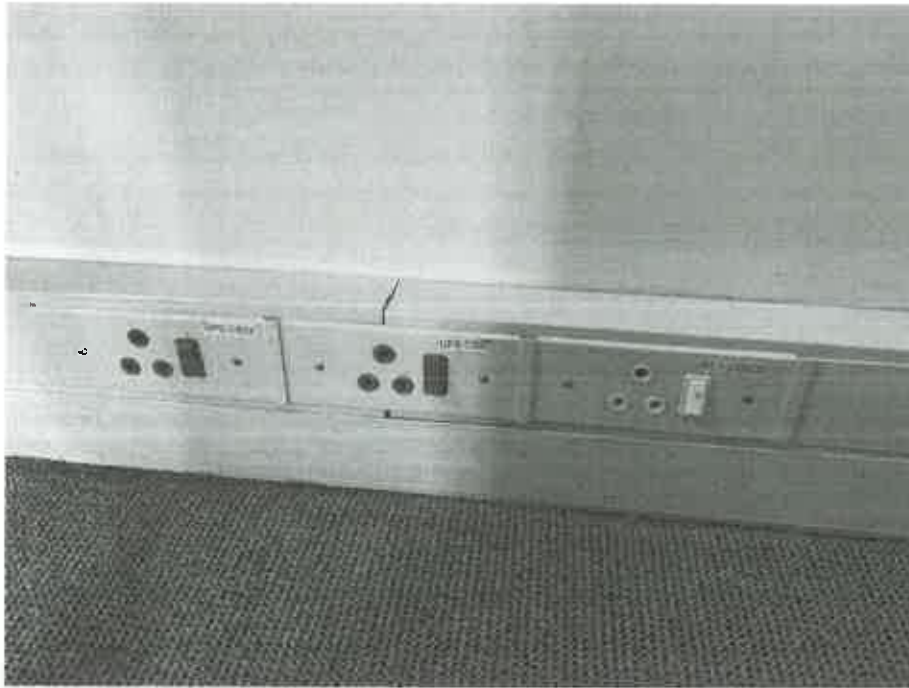
1. Generally, the electrical plug sockets are provided in a sequence combination of 2 dedicated red switched socket outlets with a white normal power plug socket.

Figure 1: Typical plug configuration on power skirting

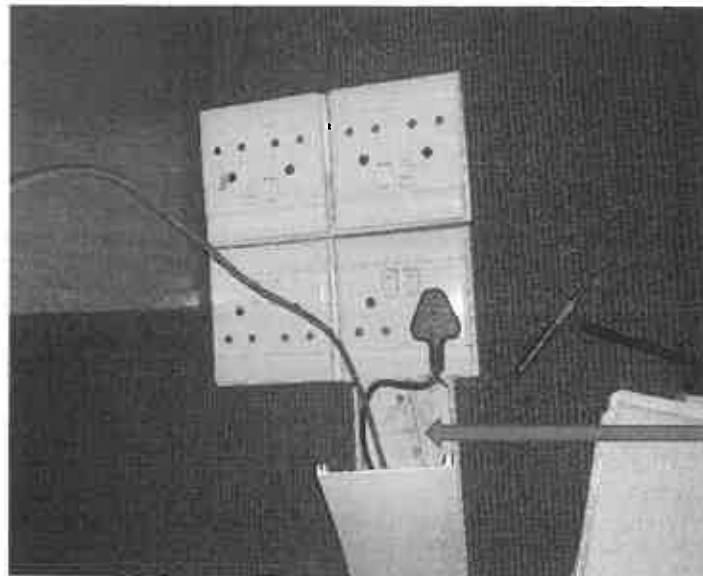
2. In order to increase the availability of power sockets to users, the NCR had in the past commissioned a contractor to extend the dedicated power supply to the desks in the open plan spaces. This configuration has groups of eight power plugs being supplied through a single 2.5mm² 3 core flat cable.
3. The cable is linked either directly in some places to the dedicated power circuit or through a single plug point on the existing power skirting circuit.

Figure 2: Incorrect: dedicated power plug sockets- normal plugs used

Single 2.5 mm² 3 core
cable supplying 8 plugs

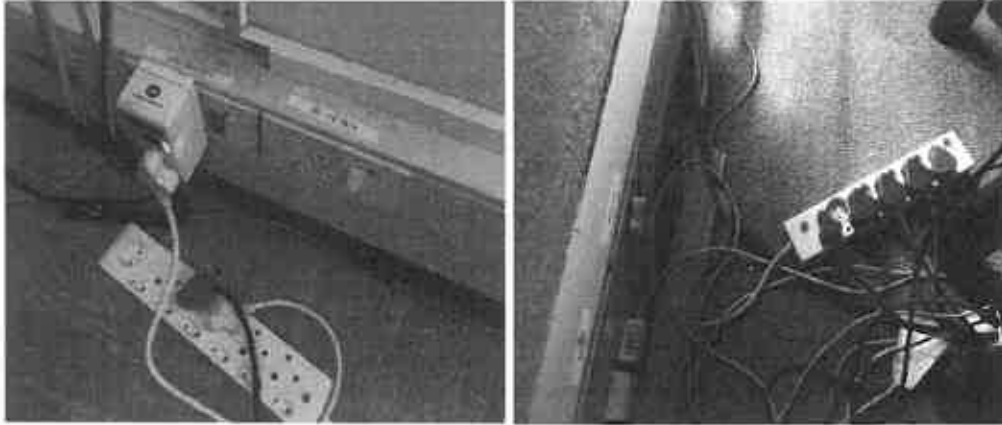
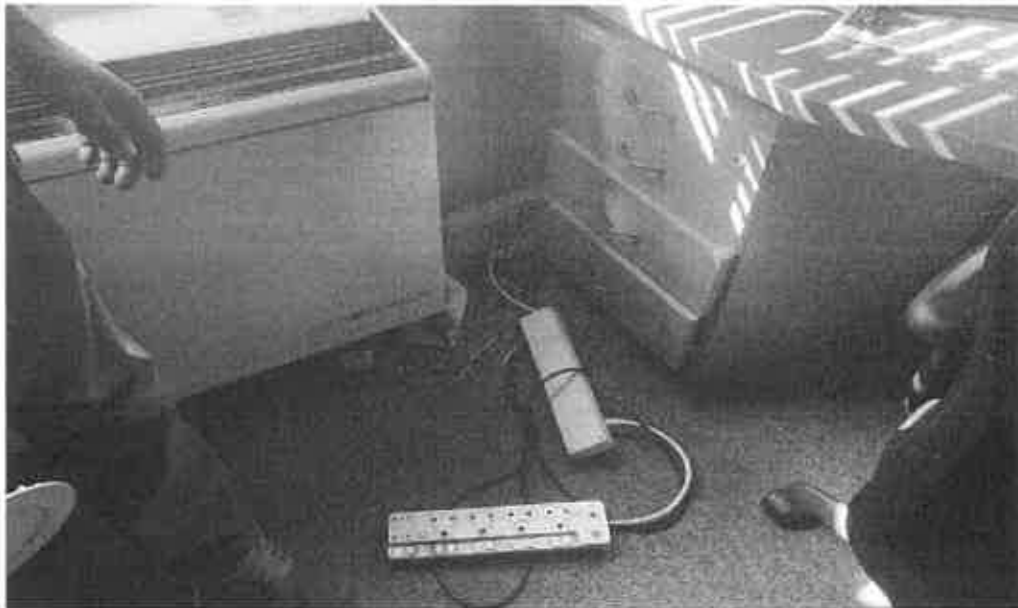
6. There a number of occasions where a range of multiplug extensions are used to provide power to multiple users off the same plug point. Ideally, this should be limited to two additional plugs being used off a specific circuit, for a short duration. This has resulted in the mixing of sources where the dedicated source has been loaded with many normal load sockets via the use of multiplugs and other extensions. One example found was a normal multiplug plug top that has been forced into a dedicated socket outlet.
7. Examples were also found where DEDICATED socket outlets have been supplied off the NORMAL supply circuits. These points have labels indicating (off normal power).

Figure 4: Normal multi-plug adapters on dedicated power supply sockets

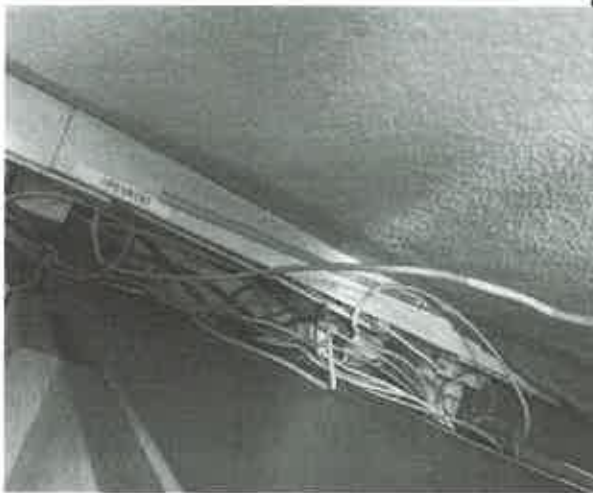
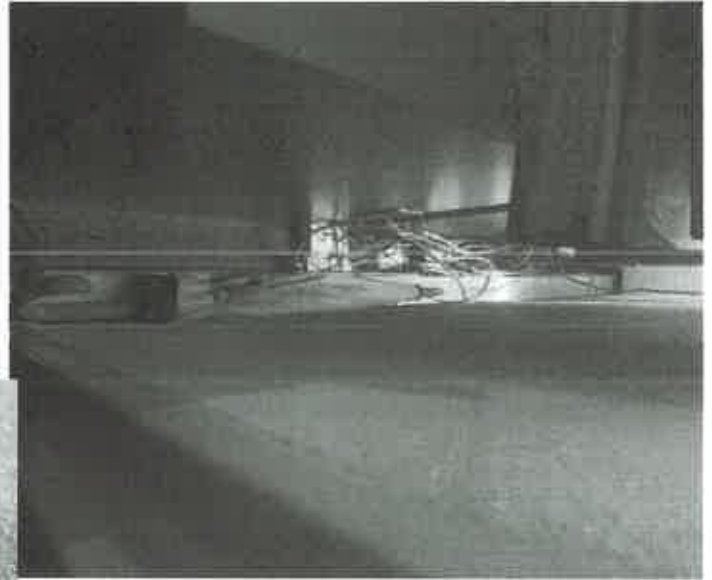
8. In many cases attempts have been made to identify the circuit breakers of supply to the sockets by means of labels at the outlets. This has revealed that many circuits are overloaded with some supplying over twenty socket outlets. It is also apparent that the labelling is inconsistent, with many socket outlets not labelled at all.
8. The current configuration of the electrical circuits represents both a Health and Safety risk and a compliance issue to building codes.

Figure 5: Potential risks related to the current configurations of plug sockets

- e. All unsafe wiring must be rectified, plug outlet socket need to be fixed correctly and properly to the power skirting. All power skirting covers should be installed properly.

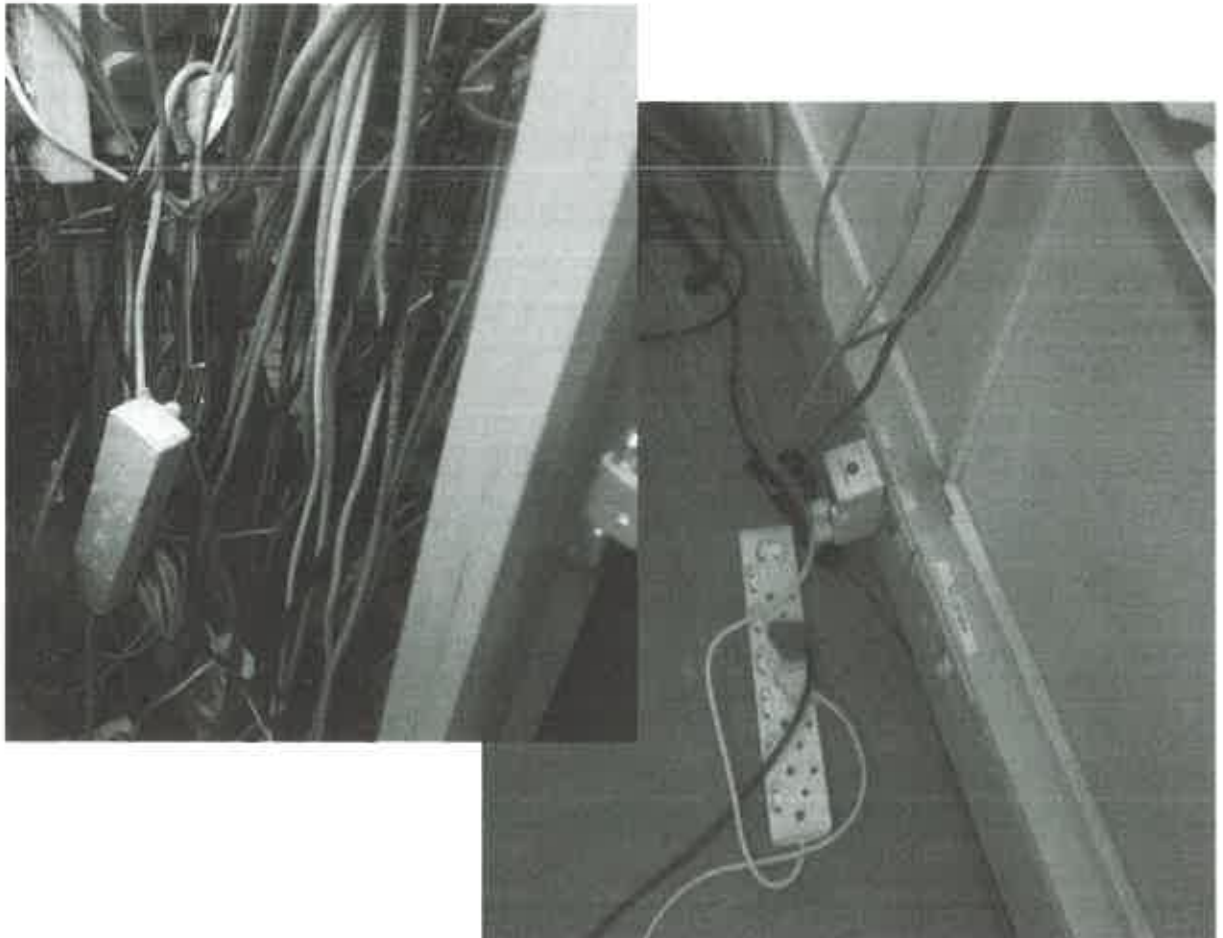
5. Three servers indicated faults as they were connected to the power skirting in the server room, which also had dedicated power supply. Notably, there was also an extension cord plugged into the circuit, which is a normal 10-amp cable, which was running warm to the touch. This

indicated an overload on that extension cable large power use, likely for the cable to have a fault when the air-conditioners tripped on no power supply.

Figure 6: Extension plug providing power to servers from power skirting

- g. A planned outage period should be arranged to structure the supply points and cabling in the server room. The reticulation in the server room must be re-organized neatly to ensure that the

various points of demand are properly serviced by the supply points in the room. Where needed, additional supply points should be implemented.

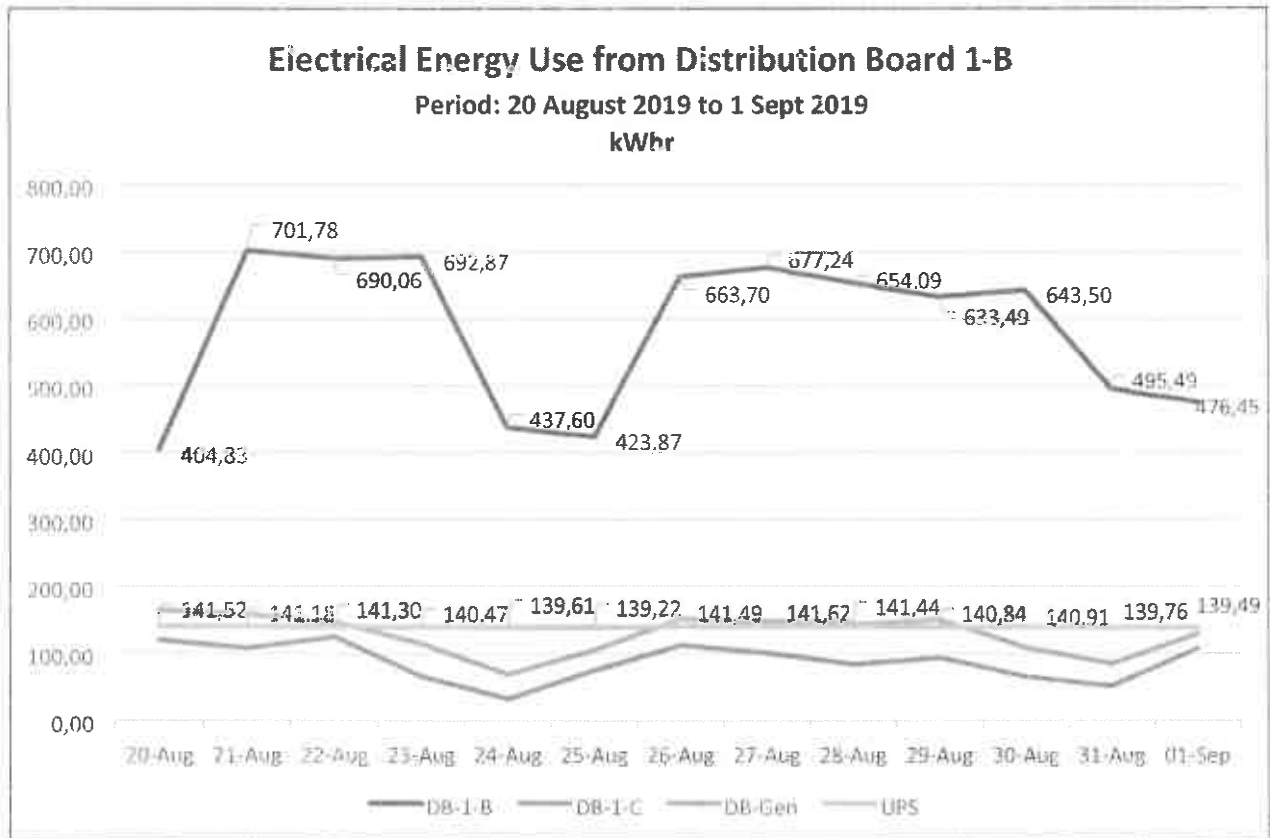
Figure 7: Electrical Power Use from Distribution Board 1-C

1. Typical usage per day during the week is in the order of 600-700 kWh per day for the areas supplied by DB 1-B. The usage during weekends (when there is limited staff on site) is approximately 400-475 kWh.
2. The constant use from the Servers is indicated to be approximately 140 kWh per day. The usage from other uses during the week account for approximately 460-560 kWh per day and 260-335 kWh per day on weekends.
3. From this can be inferred that there is still significant amount of energy being utilized per day even during weekends during times when the majority of the staff are not on site. Typical utility uses that can be accounted for would be lighting at night, server room air-conditioners and power to security features. This is estimated to be approximately not more than 150 kWh per day, thus the

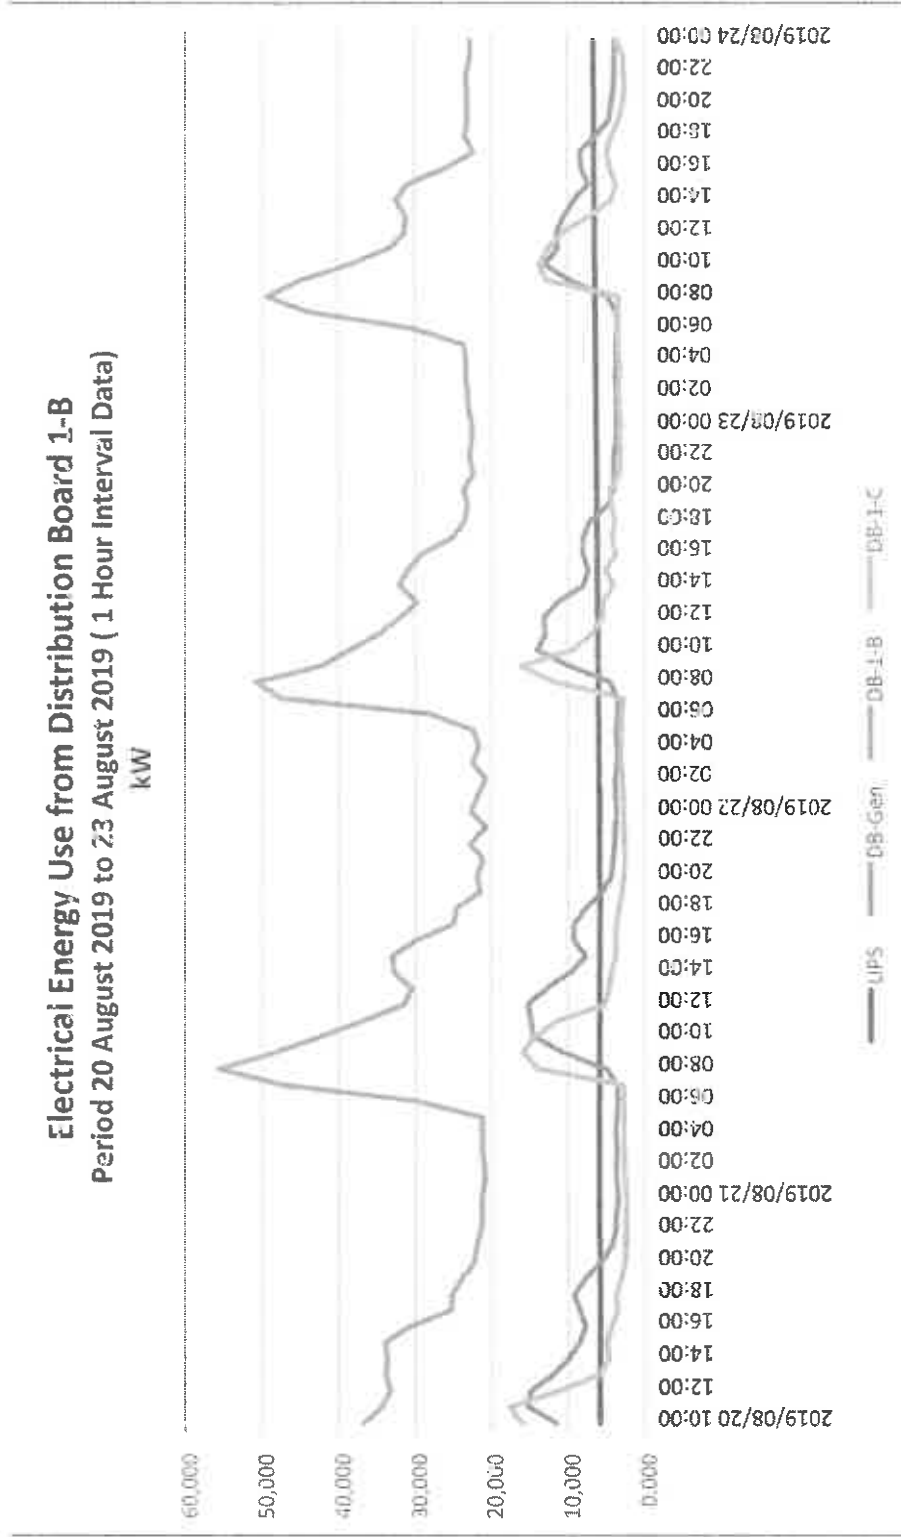
Figure 8: Electrical Power Use from Distribution Board 1-B

1. Morning start each day draws peak demands between 06:00 and 09:00. A decline in energy usage occurs from thereon until after lunch when there is typically a small peak and then a decline to close of day.
2. Typical nighttime use approximately 20-22 kW per hour. The servers draw approximately 6 kW of this power.
3. The startup use per day could be typically attributed to air-conditioner use.
4. Opportunity exists to smoothen the peak demands in the morning by possibly sequenced start of air-conditionings.
